OVERSIGHT

Executive Summary

The West Valley Demonstration Project began the vitrification of high level radioactive waste on July 2, 1996. On Saturday, November 16, 1996, the facility experienced a migration of dilute radioactive material into the demineralized-water line outside of the confinement cell. The event occurred during backflushing operations intended to improve the sampling slurry flow rate. As a result of this material outside the cell, high radiation alarms were received in two of the operating aisles and the operating aisles were evacuated. After the event, the Department of Energy (DOE) and West Valley Nuclear Services (WVNS) management both commissioned teams to investigate the event and to propose corrective actions. On January 13, 1997, the DOE Office of Oversight conducted an independent followup review of the event and the corrective actions. The purpose of this review was to ensure that appropriate corrective actions were taken by management and to issue a report that could provide lessons learned to the DOE complex.

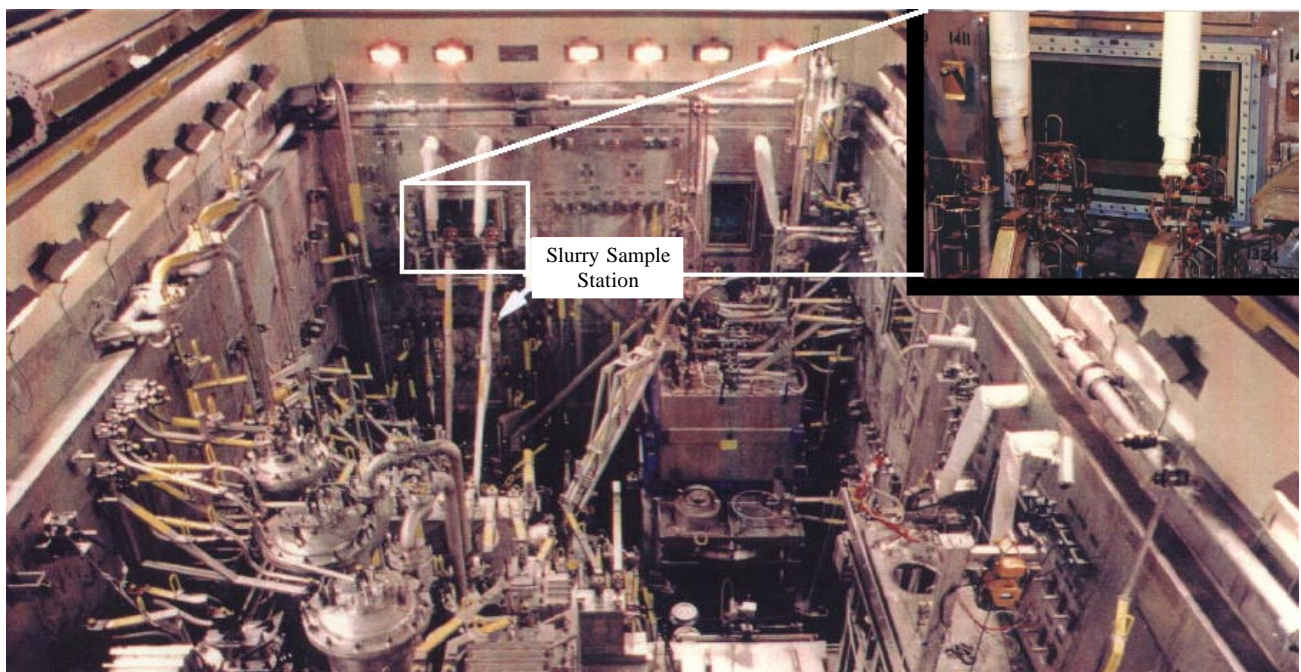
A view of the sample station from inside the vitrification cell. The inset shows the manipulators and window where operators draw the samples. The CFMT sampler is on the right.

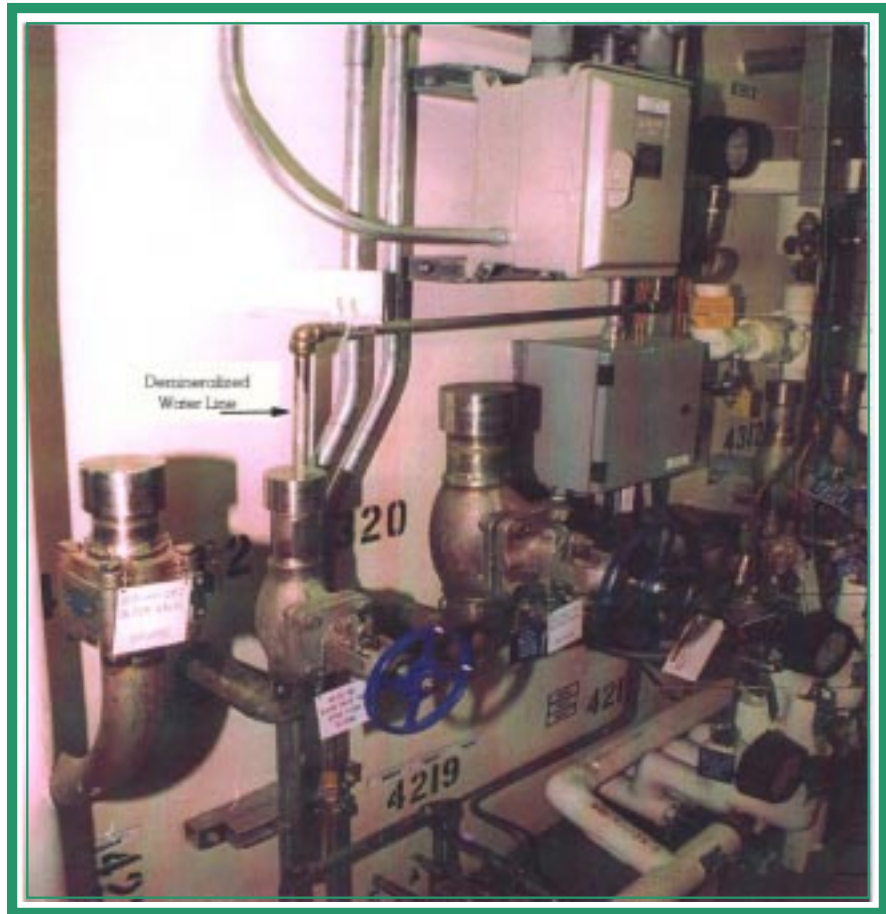
Demineralized Water Line in the Operating Aisle where Slurry Was Flushed out of the Cell

- The contact radiation levels at the demineralized-water line outside the cell were probably much higher than the 3.1 R/hr reflected in the occurrence report. WVNS calculations indicate that the peak level may have been closer to 20 R/hr and could have been over 40 R/hr under different conditions.

operating procedures. Modifications to the demineralized-water line isolations were identified, including moving the check valve closer to the cell wall, installing an automatic isolation valve, and modifying the existing isolation valve design to provide better leak protection around the valve stem. Other in-cell components and systems were evaluated for possible exit pathways and the need for additional isolation. Briefings were conducted with all shift operating crews and engineers on these changes before resuming vitrification operations.
